**REPORT
GEOMORPHIC EVALUATION AND
CHANNEL MIGRATION ZONE ANALYSIS
ADDENDUM
COWLITZ RIVER, NEAR PACKWOOD AND
RANDLE, LEWIS COUNTY, WASHINGTON**

JULY 20, 2009

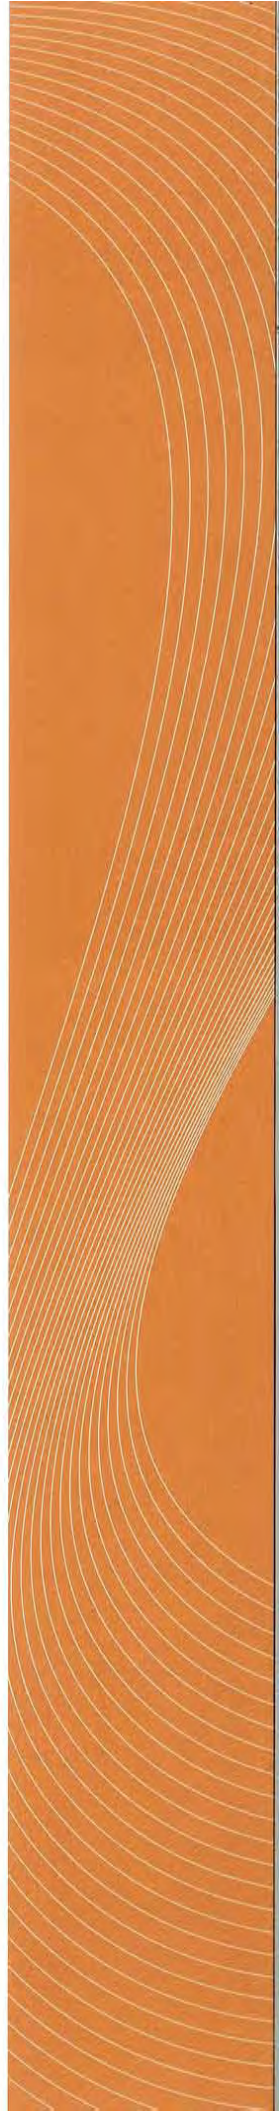
**UPPER COWLITZ RIVER
PRELIMINARY FIELD RECONNAISSANCE AND
CHANNEL MIGRATION HAZARD ASSESSMENT**

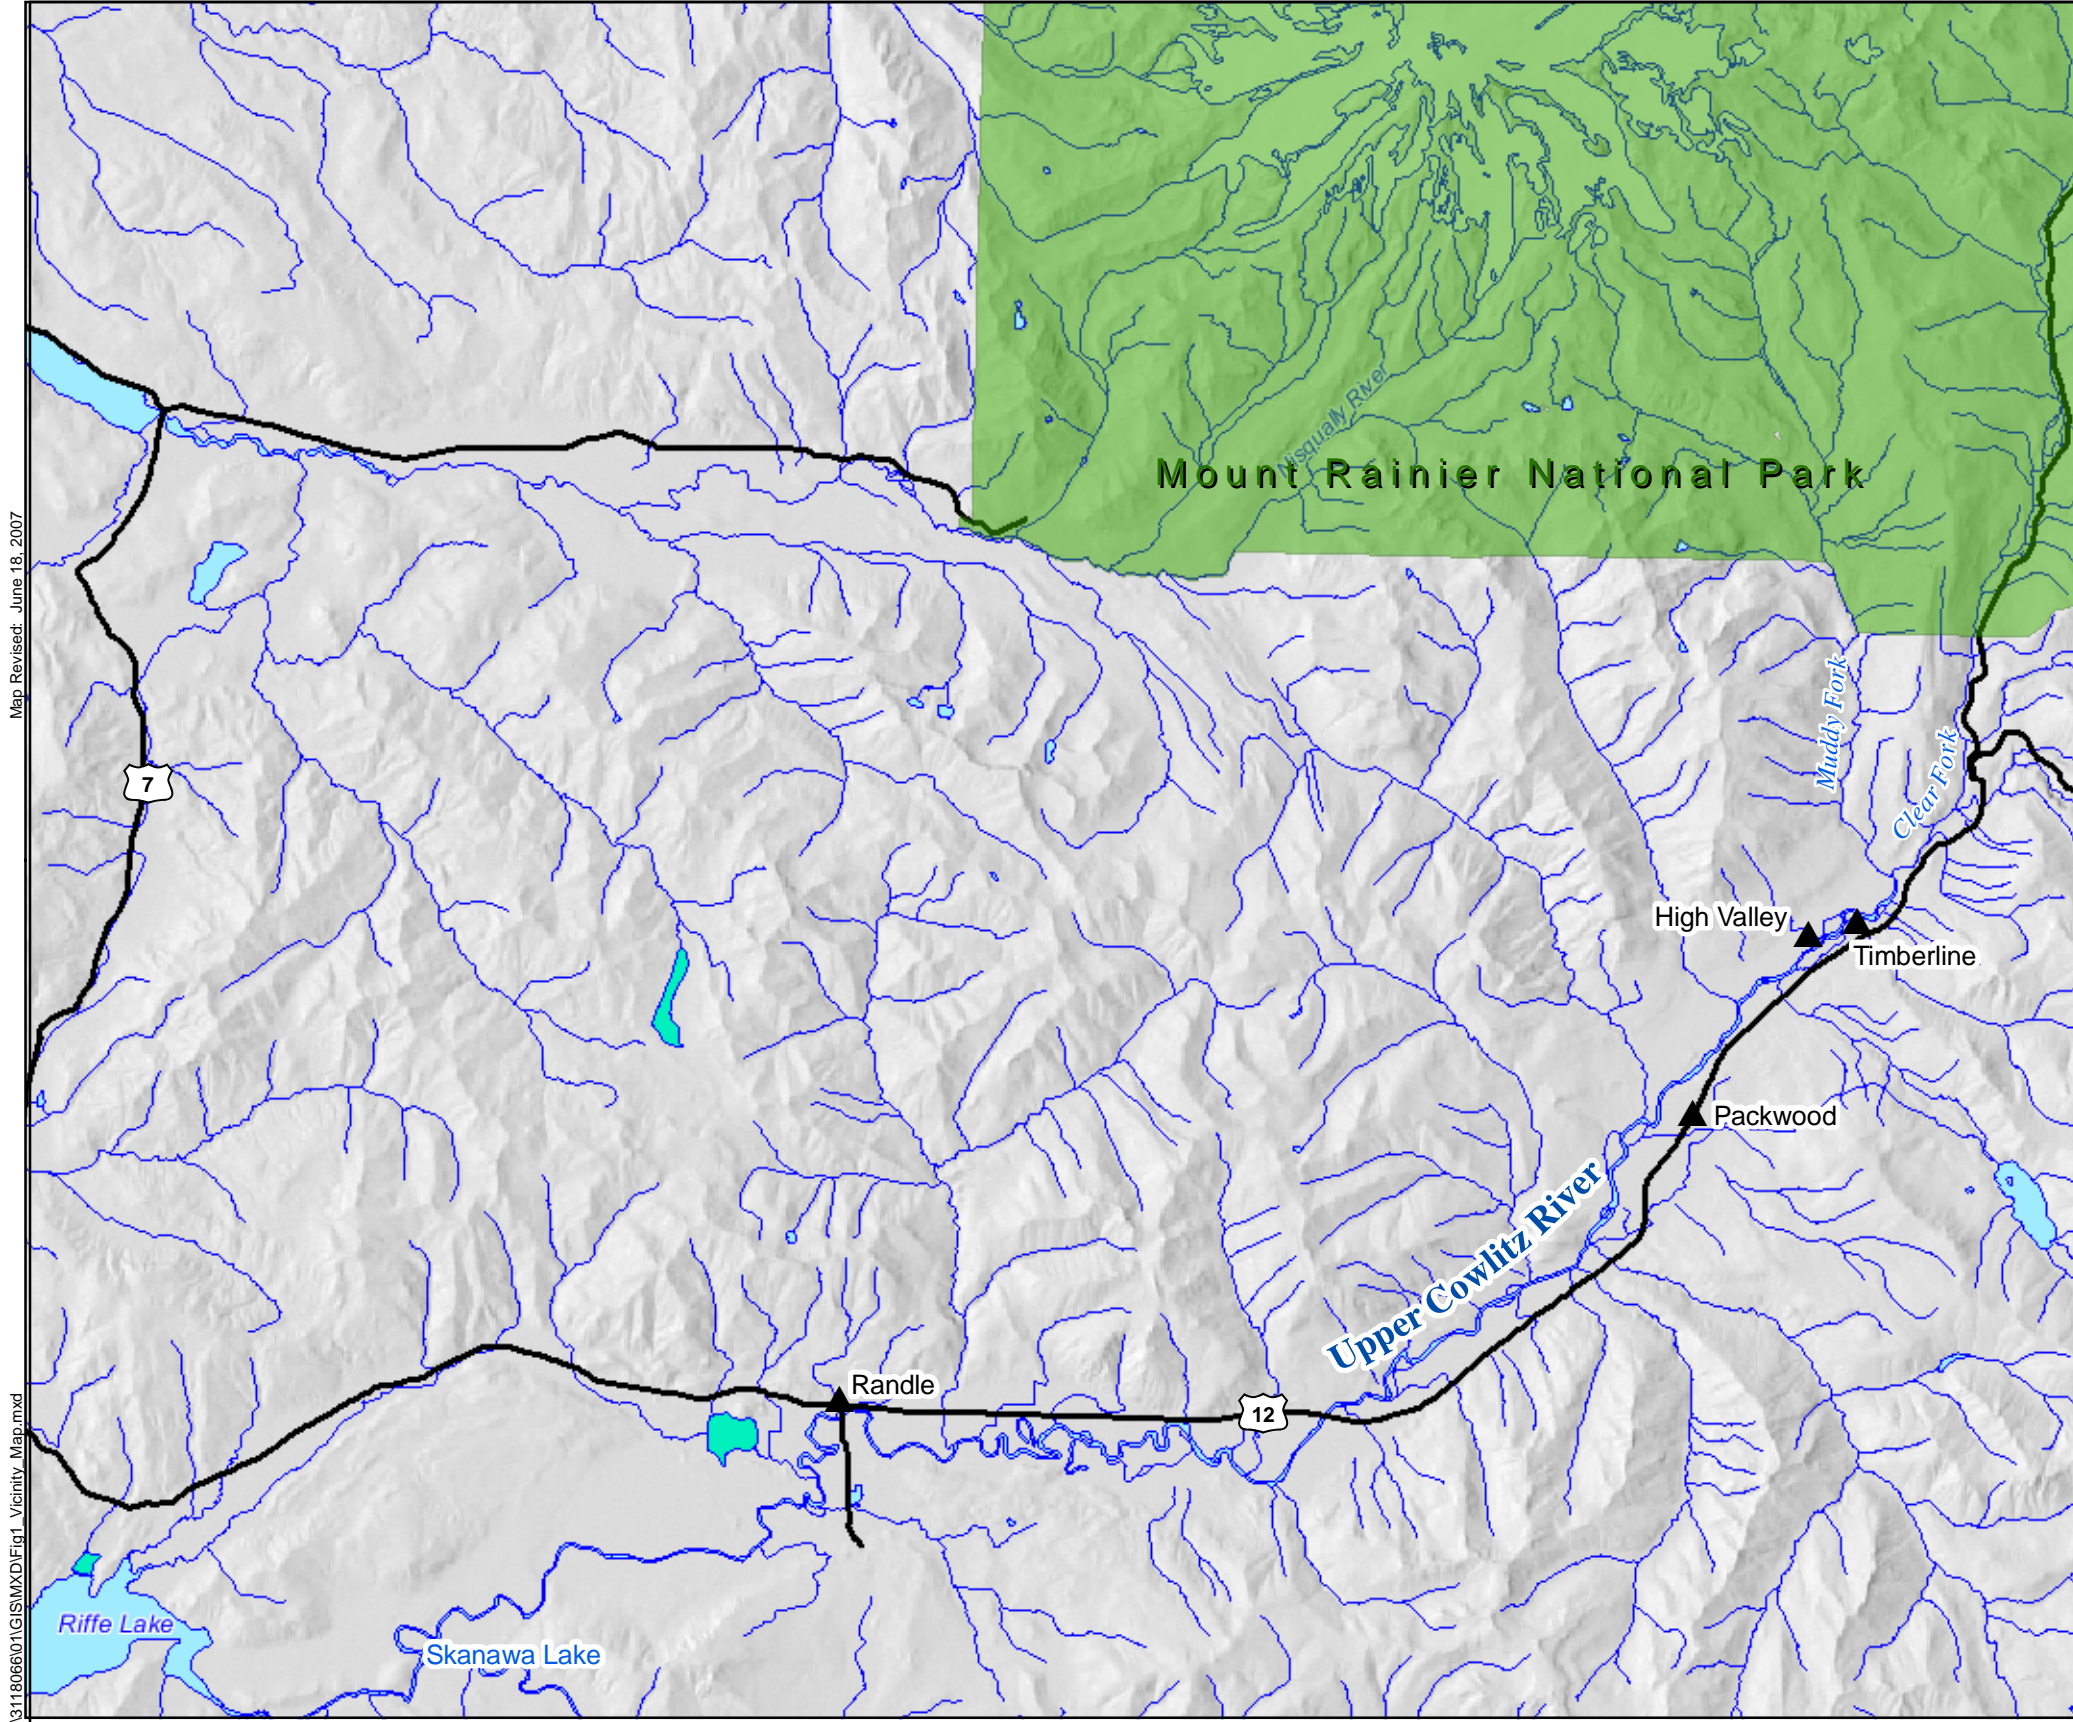
- Explanation**
- State Routes
 - Streams (100K)
 - Community
 - Interstates
 - Parks
 - Lakes
